Engineering Analysis/Report

On-Site Testing of Earthbuster – Deep Soil Decompactor

Date Tested: 7/10/23, 1:30 pm MDT

Objective: Determine direction of Earthbuster fracture seams in soils

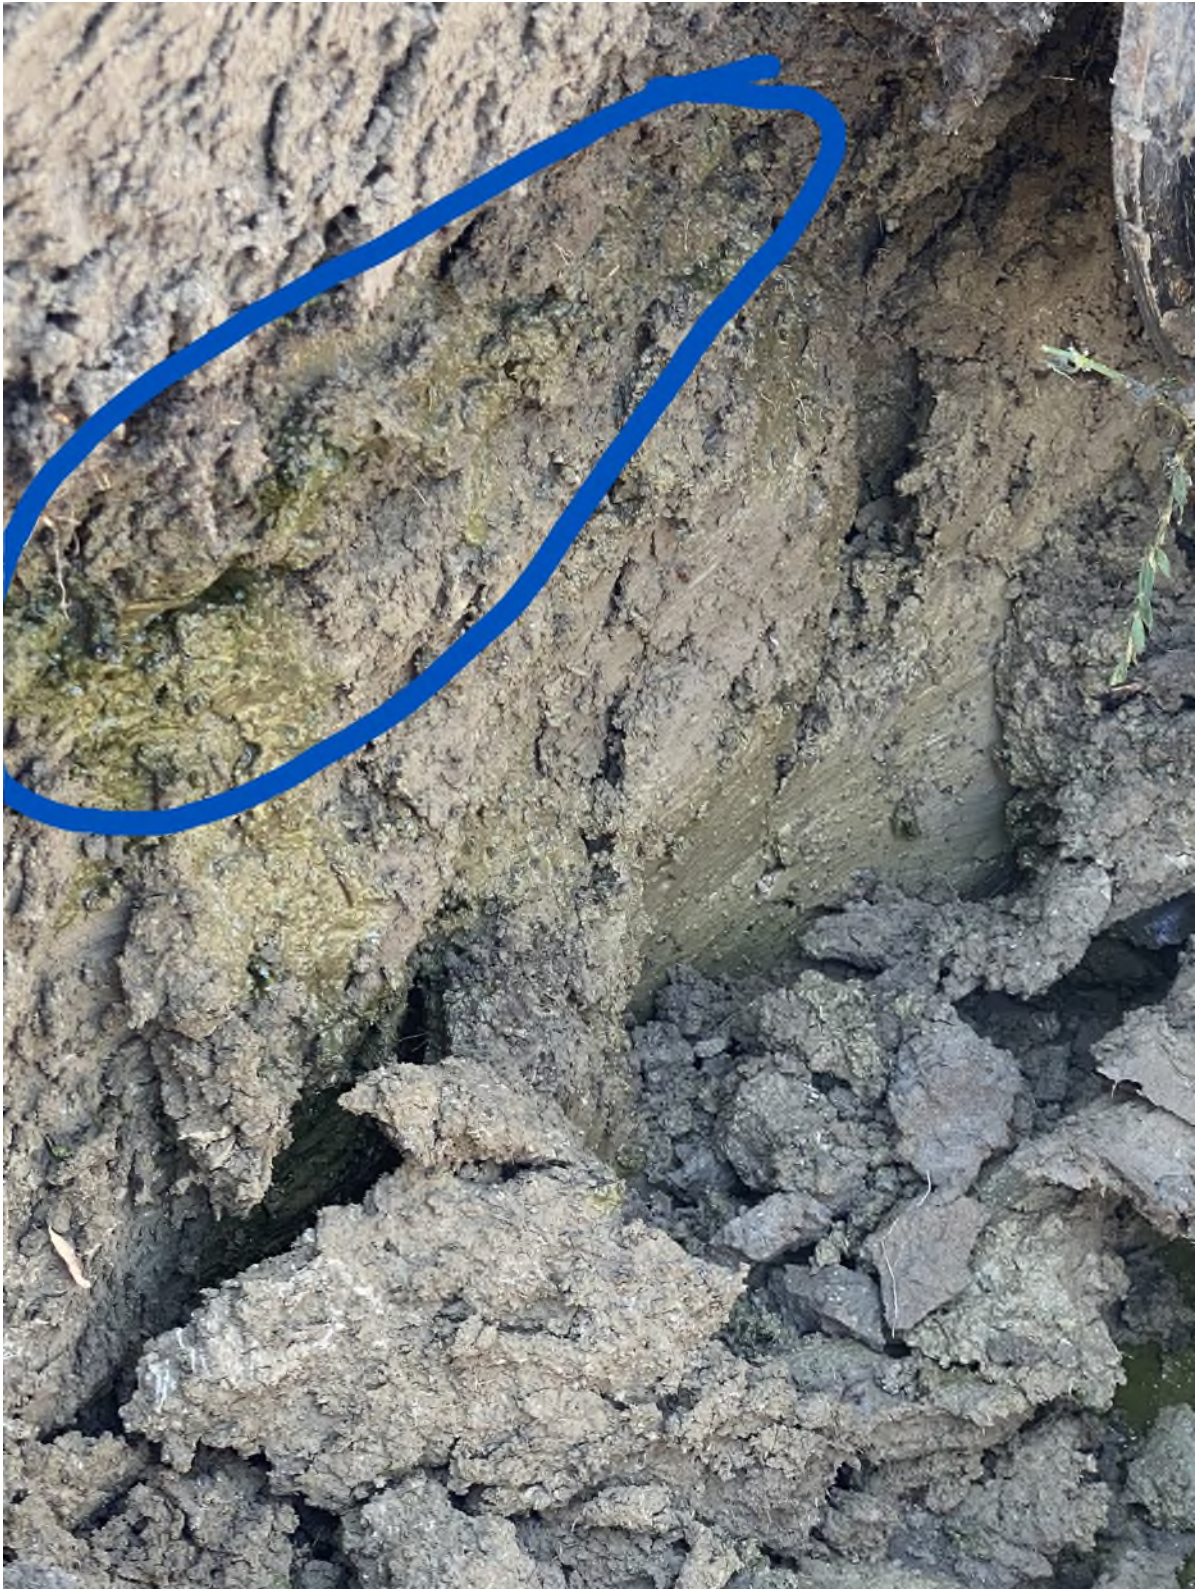
The matcha green tea tracer powder was found not to be an effective tracer material as it was difficult to identify unless directly next to the injection point. Also, higher soil moisture content did appear to be present near the test location of green tea powder. It was evident after the first test was conducted that the green tea powder was not a good candidate for the tracer powder.

Image C-2: Test 1 - Matcha Green Tea Tracer Powder – Powder absorbed into moist soil

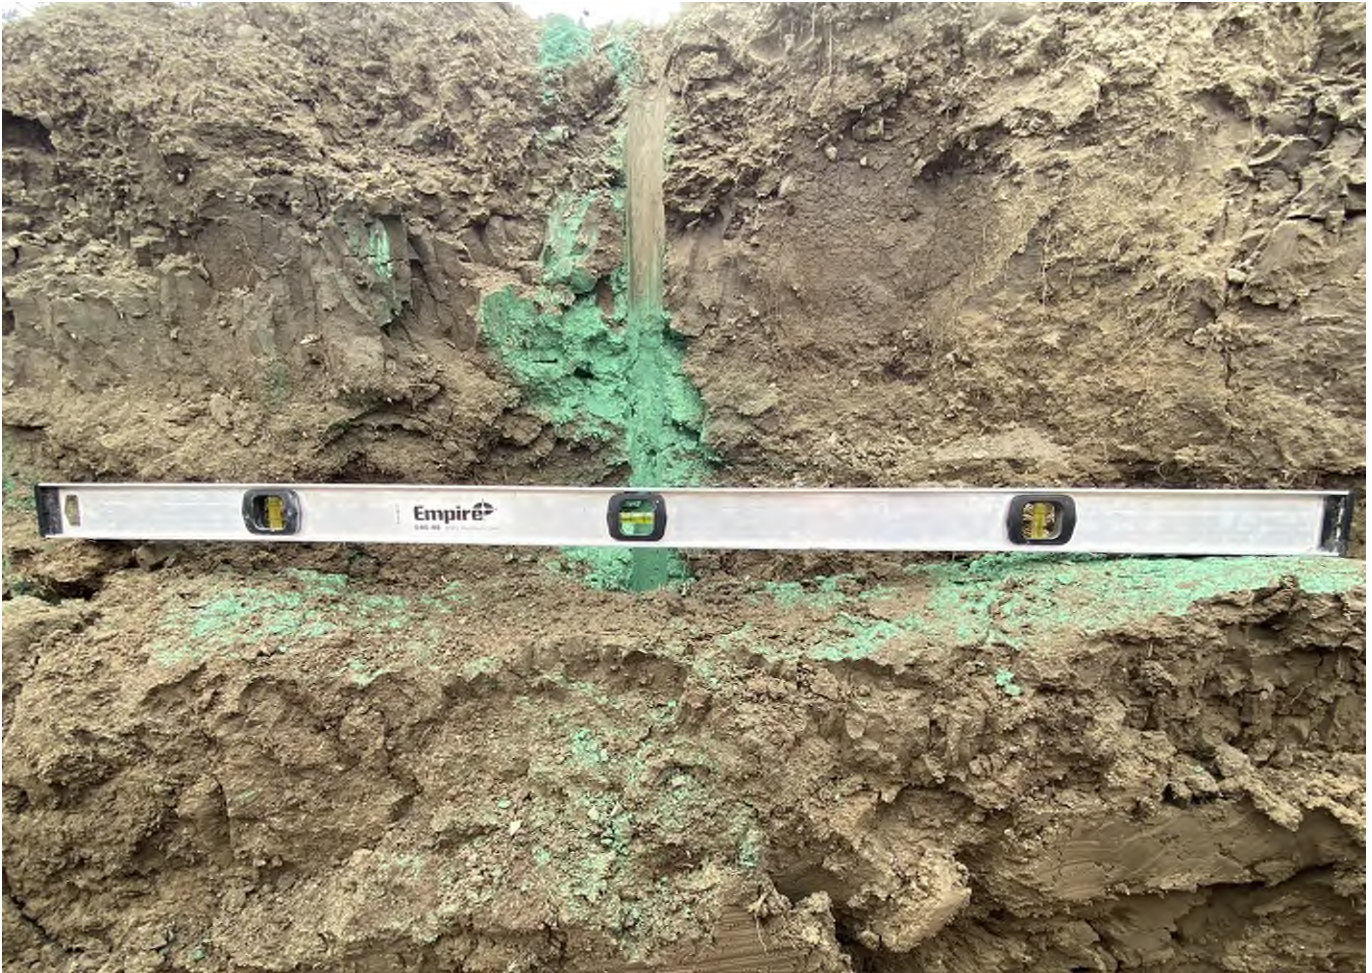
The Mica powder was identifiable and used for the last two tests as it was easily seen as compared to the tea powder. When able to identify the fracture line, removing the soil above the fracture line was in some instances possible which made it easy to see the surface of the soil that the compressed air and powder traveled. The fracture lines observed were generally directed upward towards the surface on all observed fractures during this testing to some degree. See *Appendix C Images 5 & 6*. Some of the paths of travel were slightly more abrupt and yet some were less angled towards the surface. Differing angles were thought to be due to soil conditions such as compaction/hardness, moisture content, type, structure, etc.

Image C-3: Test #2 - Upward Horizontal Fracture @ 20" Deep with Mica Trace Along Surface of Fracture

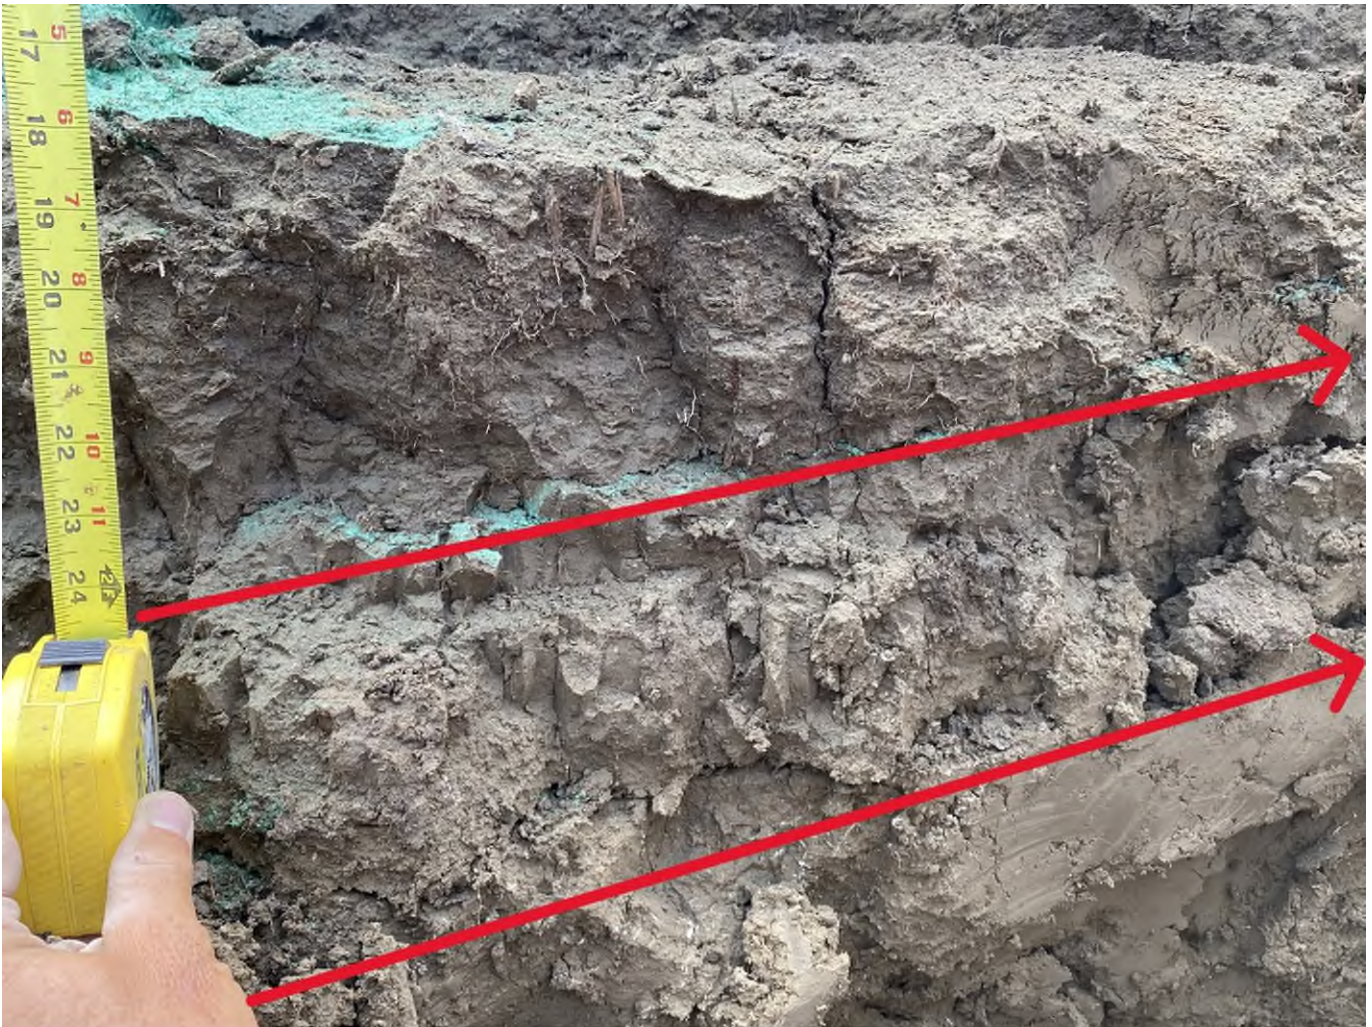
Image C-4: Test #2 - Upward Horizontal Fracture @ 24" & 31" Deep with Mica Trace Along Surface of Fracture

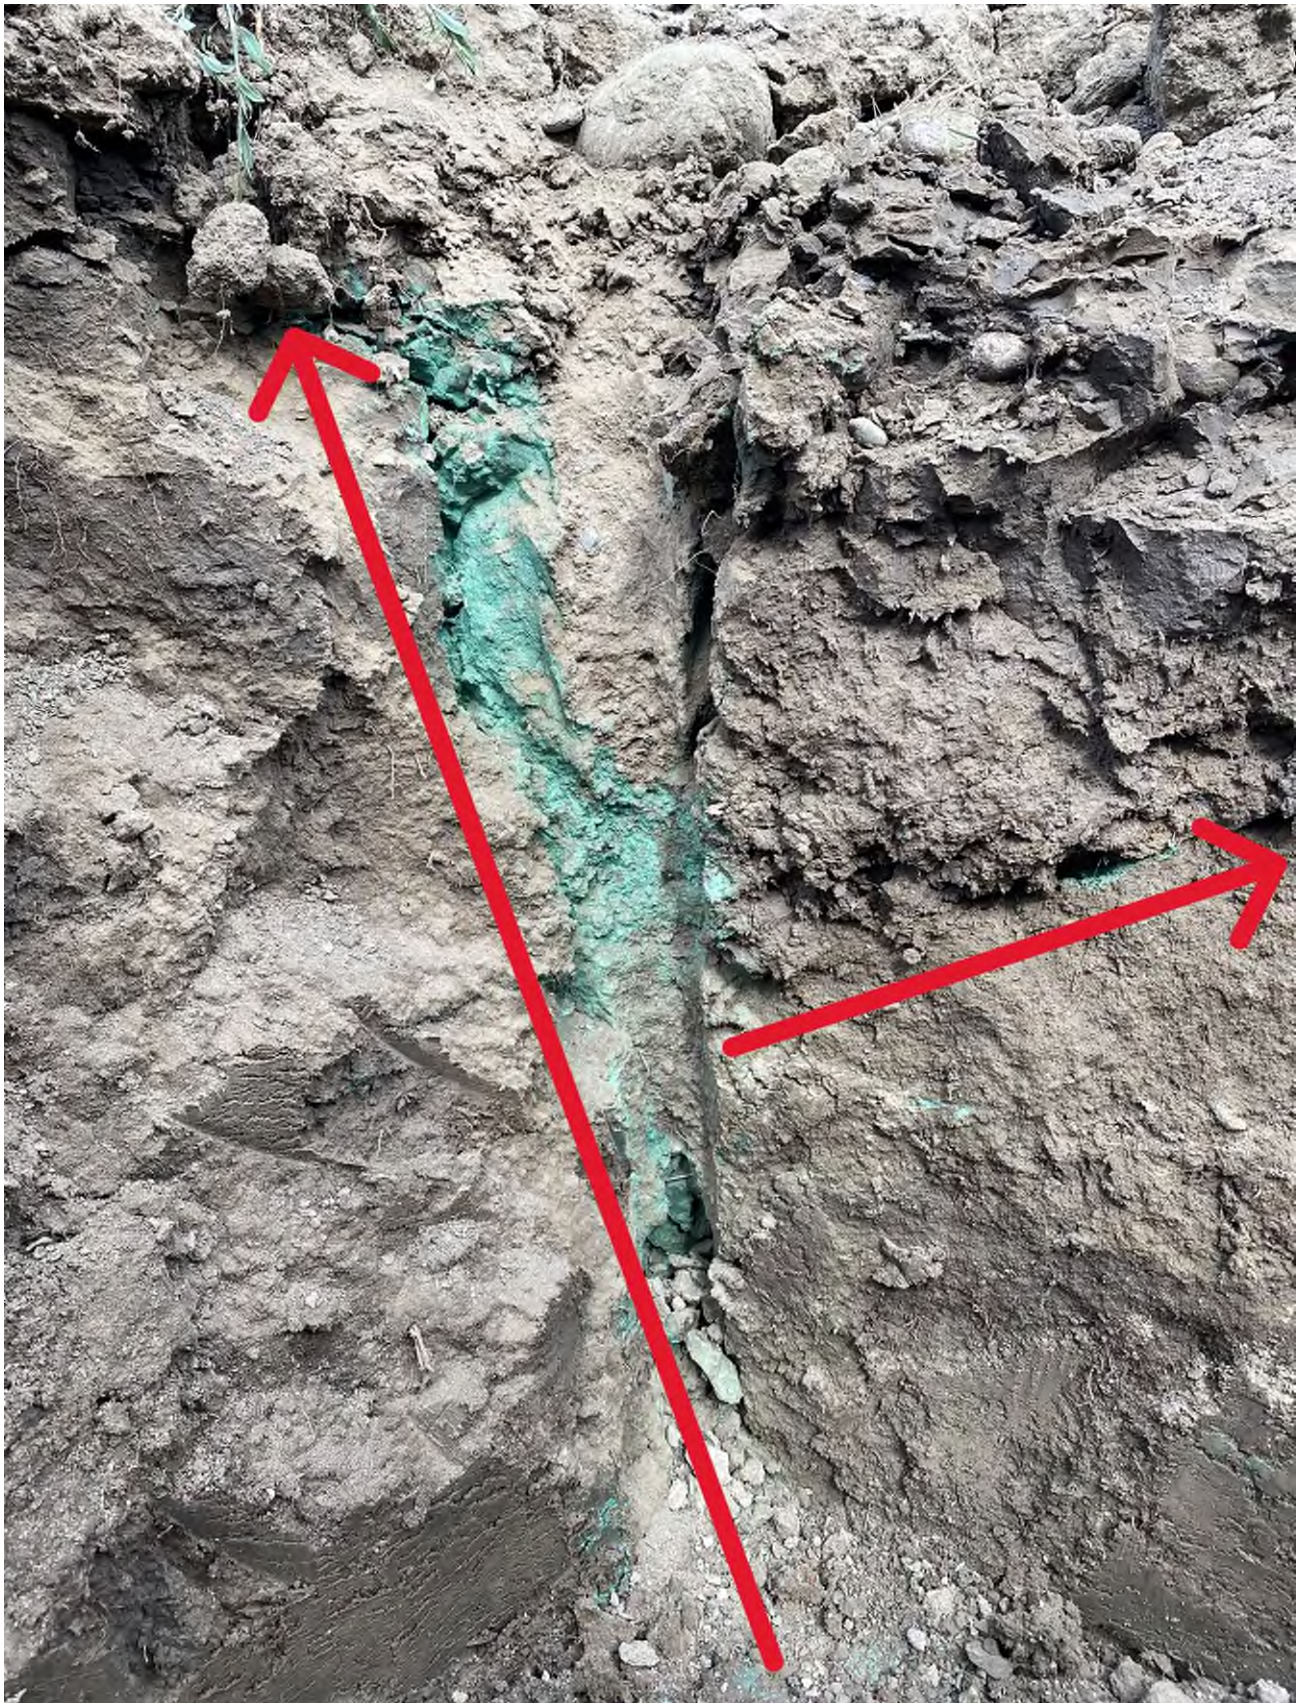
Fractures occurred randomly through the soil. Noticeable fractures that were identifiable were seen in a generally horizontal style fracture easily when close enough to the injection point. However, it seemed that some fractures would occur in a vertical manner as well from the injection point and the results of inspection showed vertical fissures that had Mica powder escape to the surface.

Image C-5: Test #3 - Mica Powder Escaped Between Towards Surface

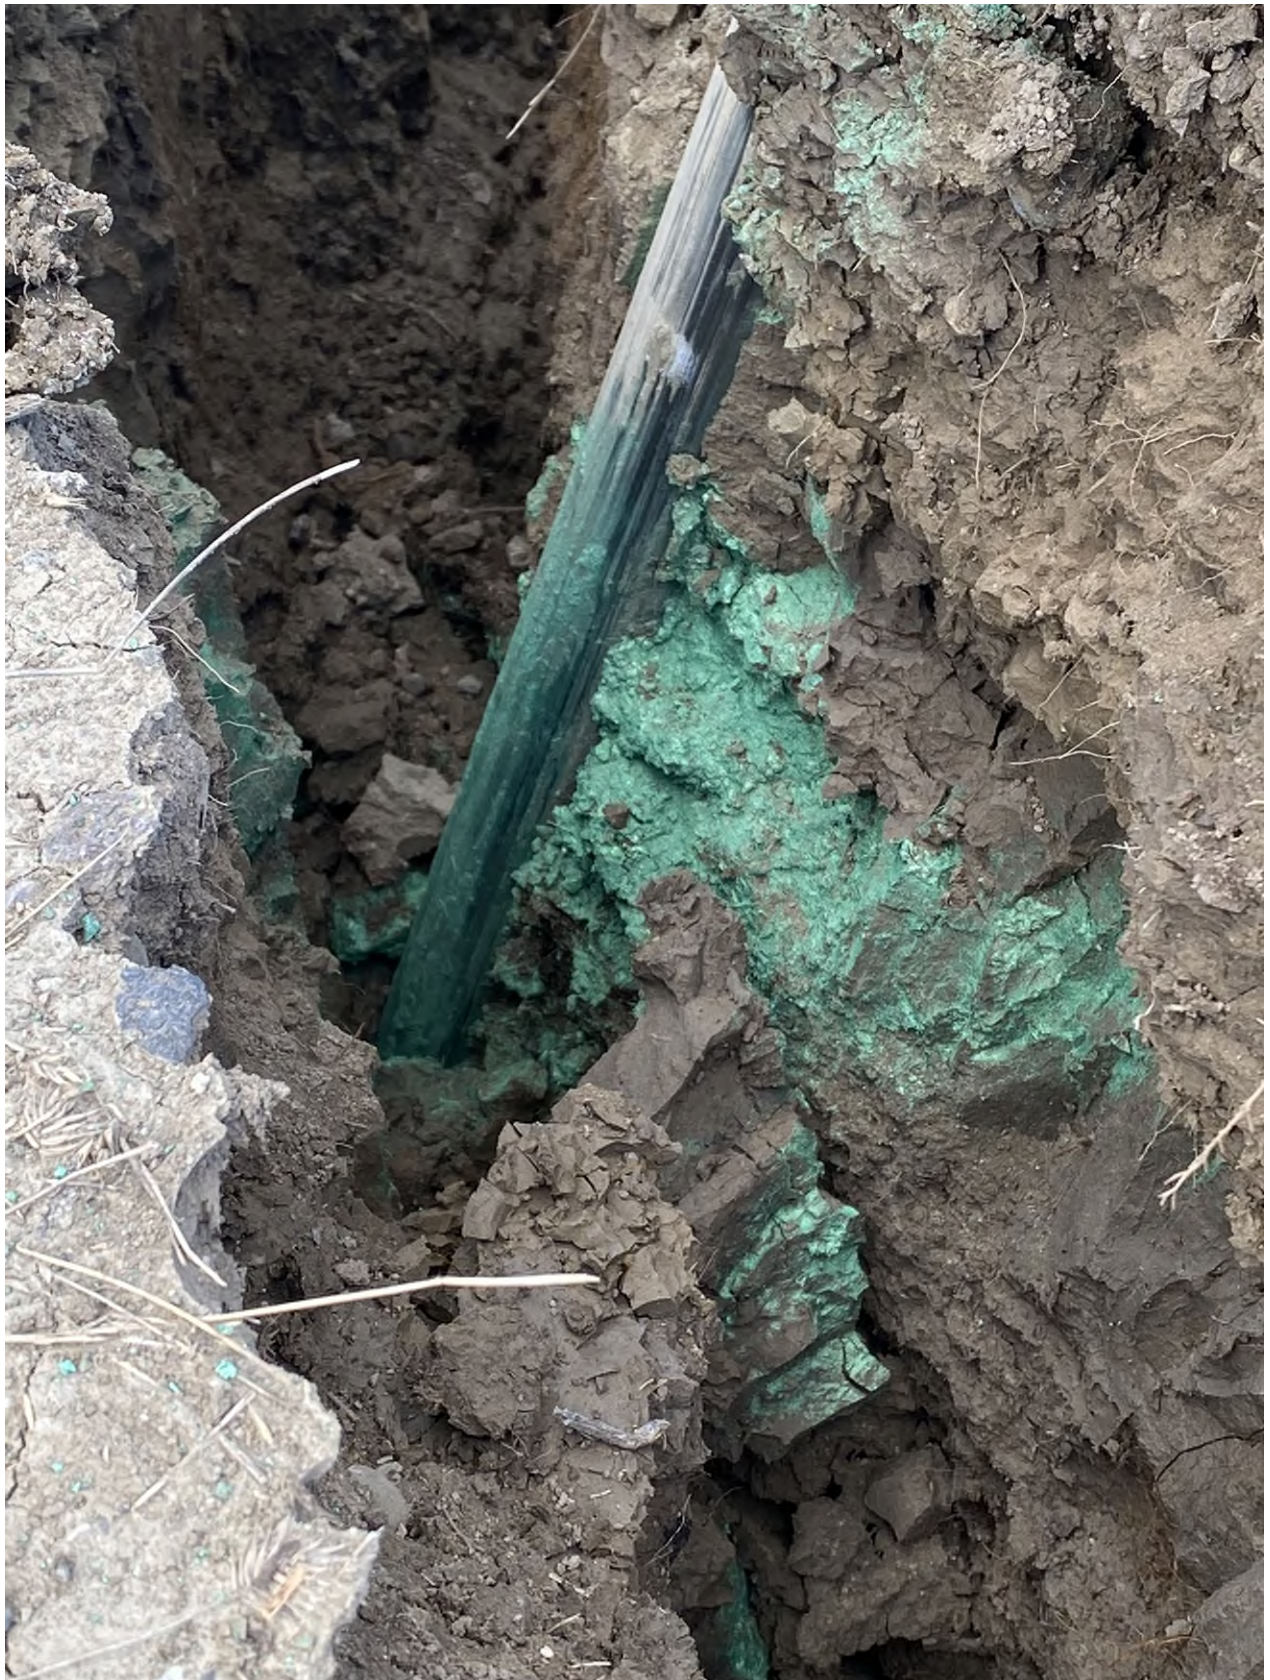
Image C-6: Test #3 - Mica Powder Escaped Between Columnar Peds Towards Surface

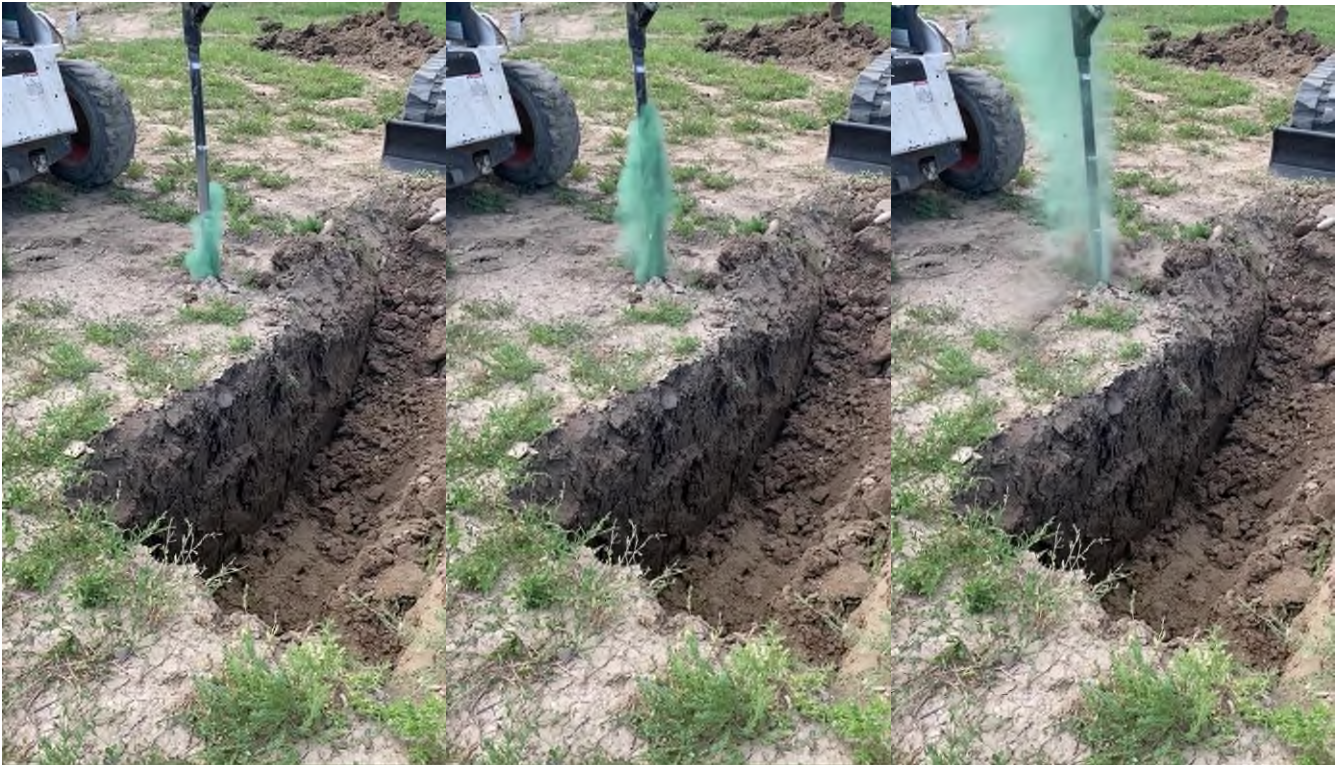
Some of the air injections did escape next to the probe. This was likely due to the probe loosening the soil as it was pushed into the ground. The vertical lift of the skid steer used theoretically should allow the probe to be inserted completely vertical without repositioning of the equipment, however if the probe was not plumb before inserting, the probe would tend to “push” against the soils slightly compressing one side of the soils against the probe and in effect creating a lesser pressure on the other side of the probe. Any movement the machinery may experience could cause loosening of the soils around the probe also. This could have been the cause for some of these results and is a condition to consider when using the Earthbuster product for maximum benefit to soil aeration.

Image C-7: Time Lapse Experimental Test Near Trench (Powder Exiting Near Probe)

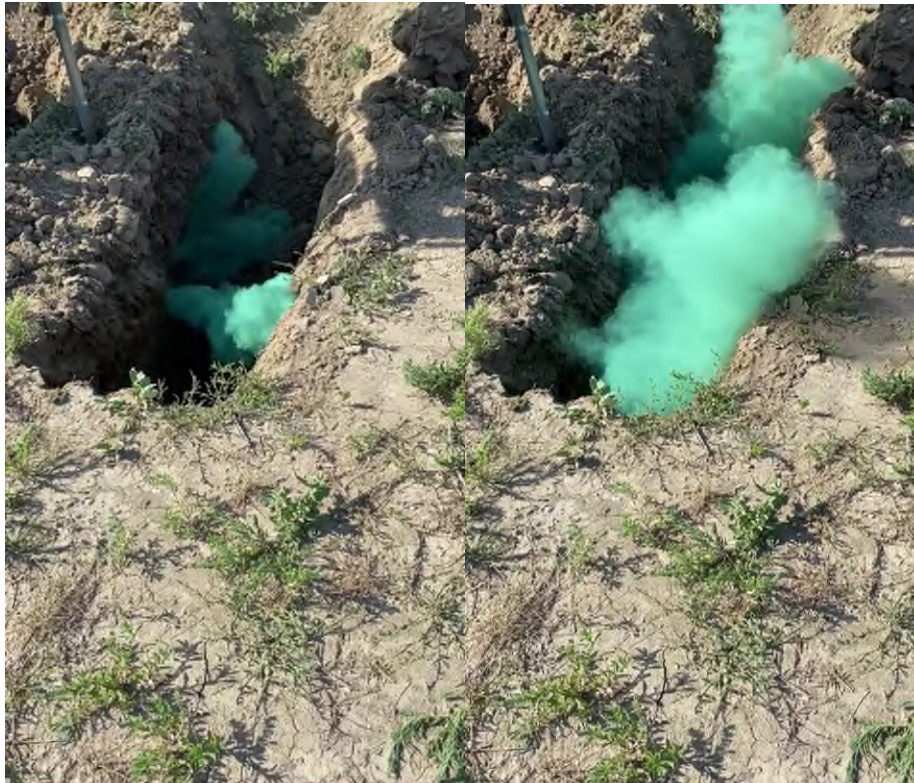
The additional experimental tests were performed with and without tracer powder to determine how the compressed air would escape next to an excavated area. Visually viewing the areas where the soil separated due to the air injection was still difficult unless soft powdery soil was present that indicated the air movement. Additional experimental tests with powder tracers were not quite as conclusive due to the powders escaping along the probe in the instances tested vs horizontally and out towards the excavation. One instance showed the powder escaping horizontally but only 8” of horizontal travel before exiting into the excavated trench did not show a definitive direction within the short amount of travel. See images 7, 8, and 9 in *Appendix C*.

Image C-8: Time Lapse Images - Experimental Test - Mica Powder Exiting into Trench

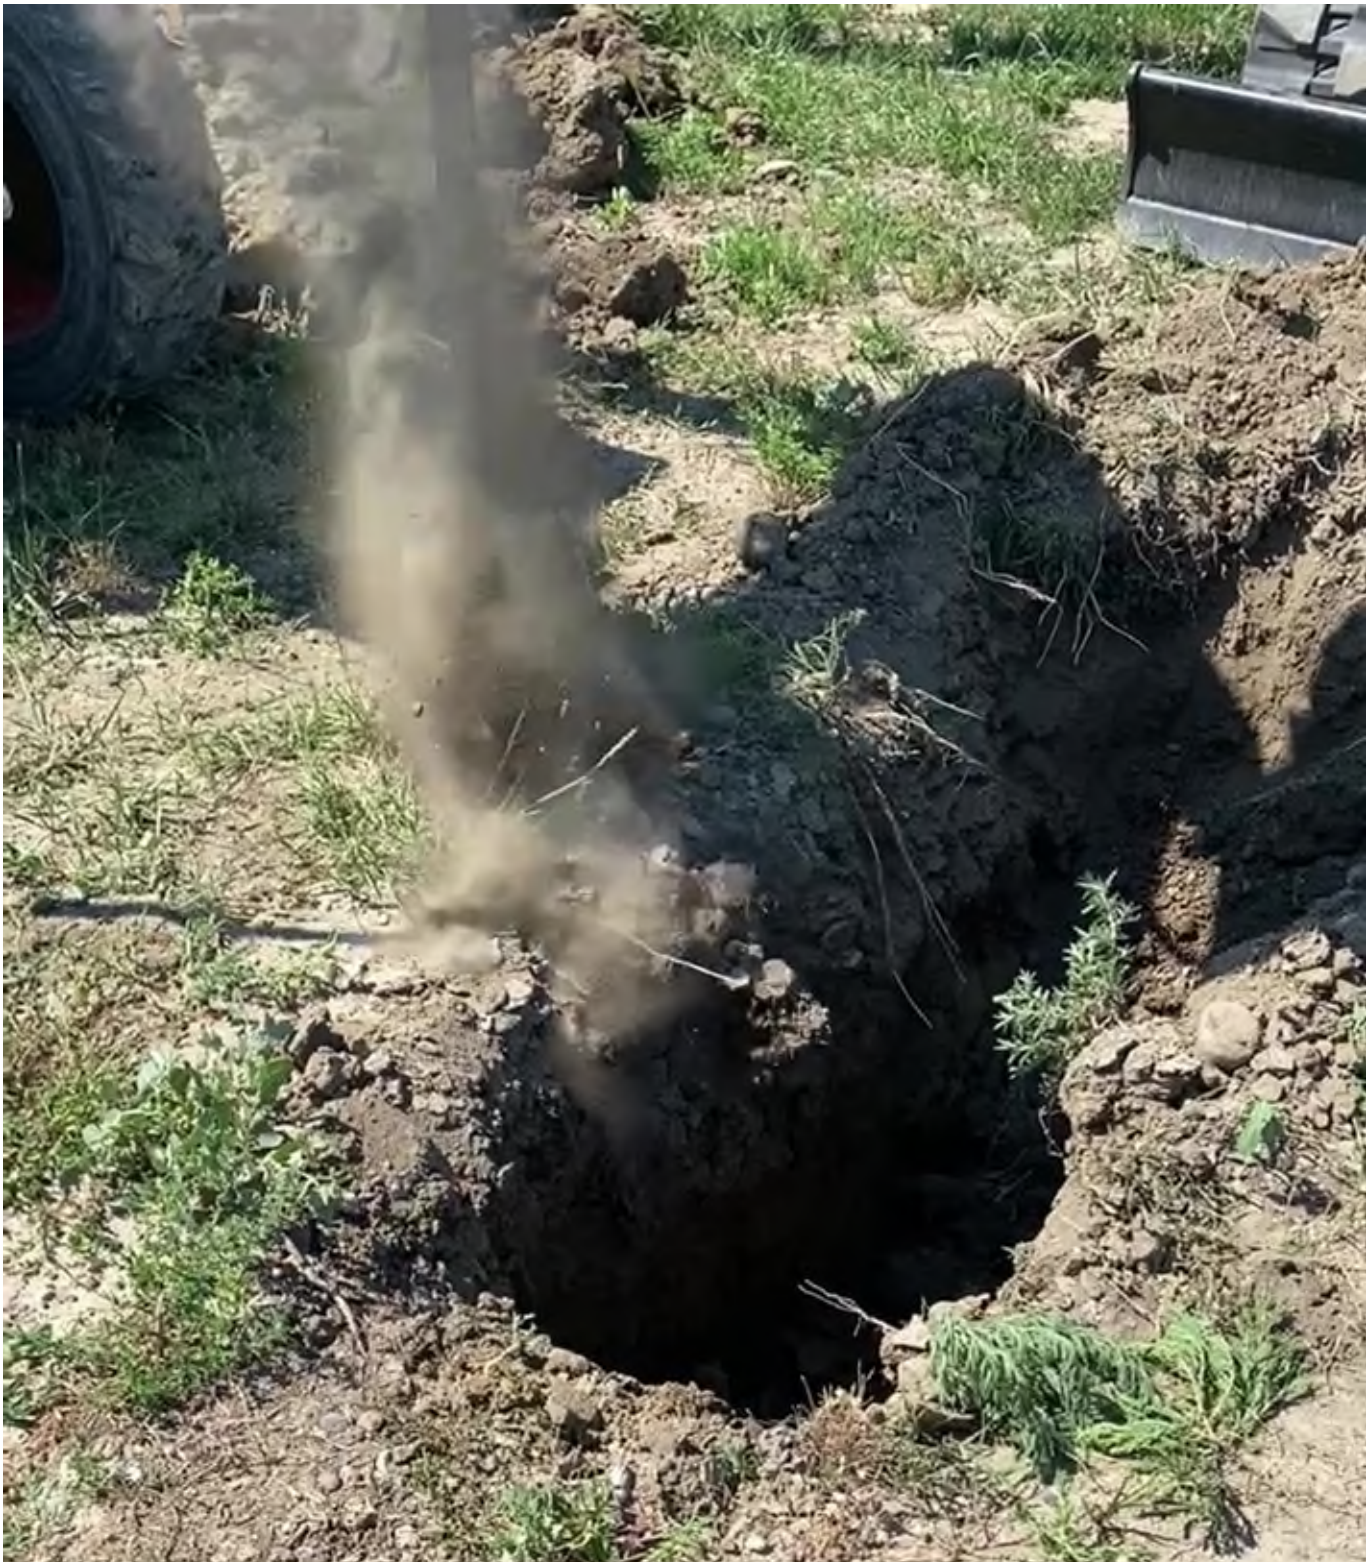
Image C-9: Experimental Test (No Tracer) Air Exiting Vertical Fracture and into Trench
