Engineering Analysis/Report

On-Site Testing of Earthbuster – Deep Soil Decompactor

Date Tested: 7/10/23, 1:30 pm MDT

Objective: Determine direction of Earthbuster fracture seams in soils

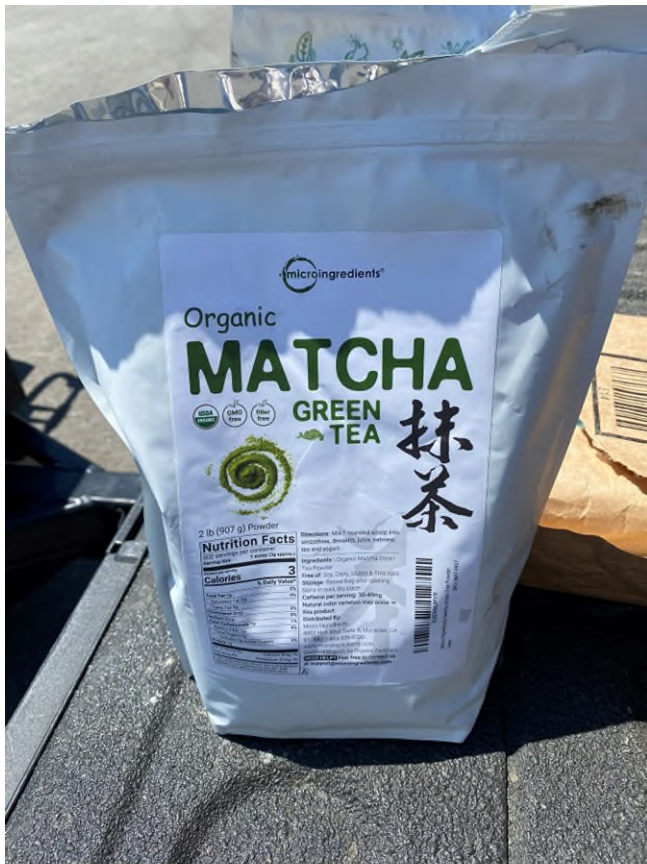
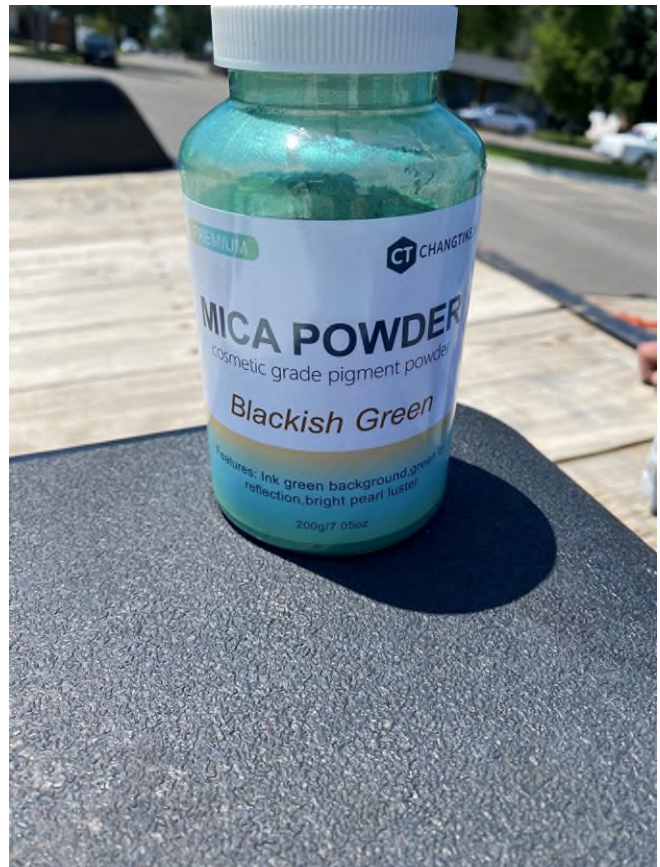
Image C-1:
Tracer Powders

The matcha green tea tracer powder was found not to be an effective tracer material as it was difficult to identify unless directly next to the injection point. Also, higher soil moisture content did appear to be present near the test location of green tea powder. It was evident after the first test was conducted that the green tea powder was not a good candidate for the tracer powder.

The Mica powder was identifiable and used for the last two tests as it was easily seen as compared to the tea powder. When able to identify the fracture line, removing the soil above the fracture line was in some instances possible which made it easy to see the surface of the soil that the compressed air and powder traveled. The fracture lines observed were generally directed upward towards the surface on all observed fractures during this testing to some degree. See *Appendix C Images 5 & 6*. Some of the paths of travel were slightly more abrupt and yet some were less angled towards the surface. Differing angles were thought to be due to soil conditions such as compaction/hardness, moisture content, type, structure, etc.
